**Test description**

| | Report no 01/01/2024 | Document no 36-DJ-R |

**Description of samples after 96 hours of exposure in the salt chamber**

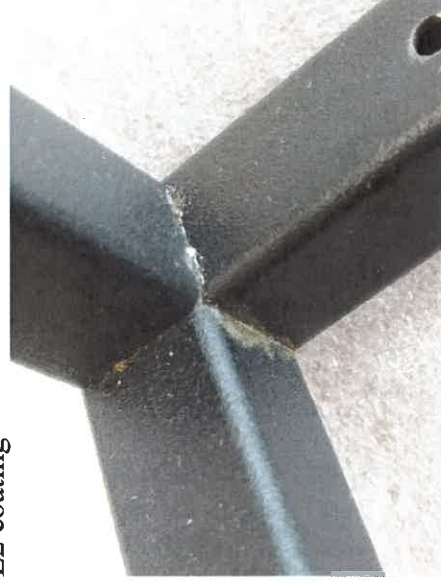
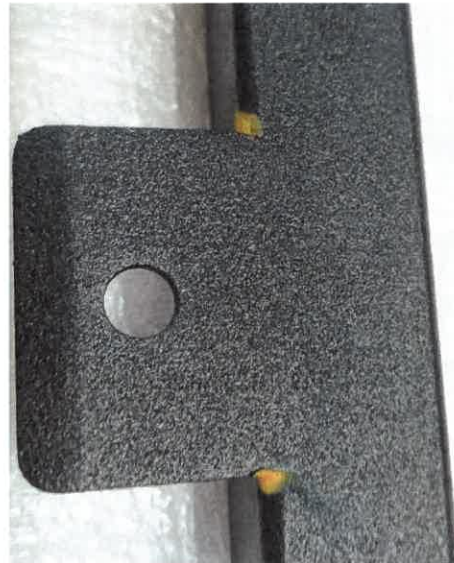
| Sample no | Product | Quantity | Description after 96 hour test |
|---|---|---|---|
| 1 | Frame in L2 coating | 1 pc | After the test, all surfaces of the angle were assessed visually. There were slight traces of red corrosion in the mounting holes. |

| No. | Sample no | Description | Test result |
|---|---|---|---|
| 1. | Frame in L2 | Slight rusting at holes, welds, in places of connection between 0,25 and 0,5 %, 7/7 s | For customer approval |

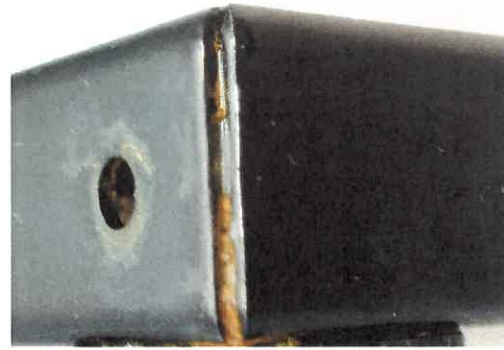
| Sample no | Product | Quantity | Description after 96 hour test |
|---|---|---|---|
| 2 | Frame in L36 coating | 1 pc | The element has been visually assessed after:<br>- 96 h - no visible changes on external surfaces; traces, leakage of internal corrosion visible at welds, mounting holes and in places of connection |

| No. | Sample no | Description | Test result |
|---|---|---|---|
| 2. | Frame in L36 | Slight rusting at holes, welds, in places of connection between 0,25 and 0,5 %, 7/7 s | For customer approval |
