**Test description**

| | Report no 01/01/2024 | Document no 36-DJ-R |

**Description of samples after 96 hours of exposure in the salt chamber**

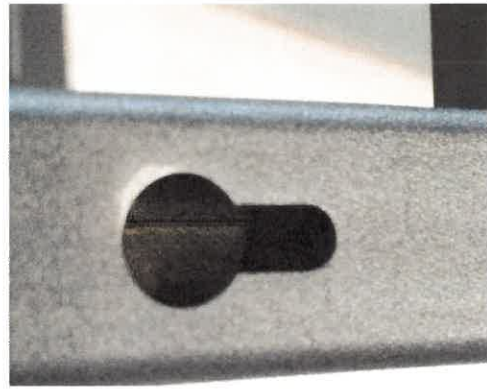
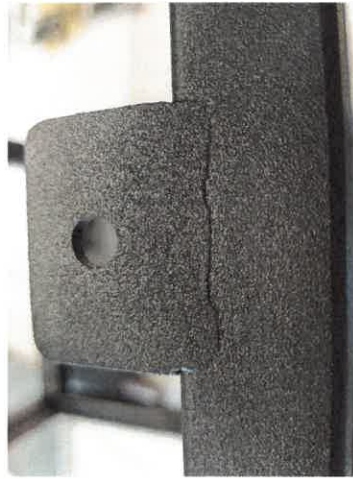
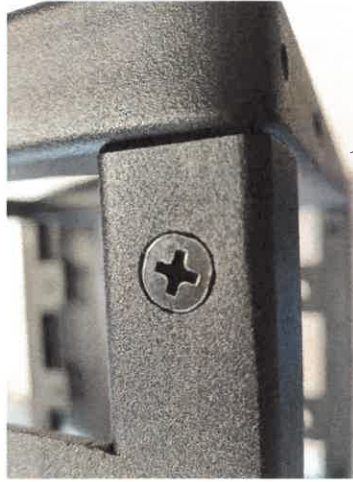
Frames before test:  
**L2 coating**

| Sample no | Product | Quantity | Description after 96 hour test |
|---|---|---|---|
| 1 | Frame in L2 coating | 1 pc | After the test, all surfaces of the angle were assessed visually. There were slight traces of red corrosion in the mounting holes. |

| No. | Sample no | Description | Test result |
|---|---|---|---|
| 1. | Frame in L2 | Slight rusting at holes, welds, in places of connection between 0,25 and 0,5 %, 7/7 s | For customer approval |

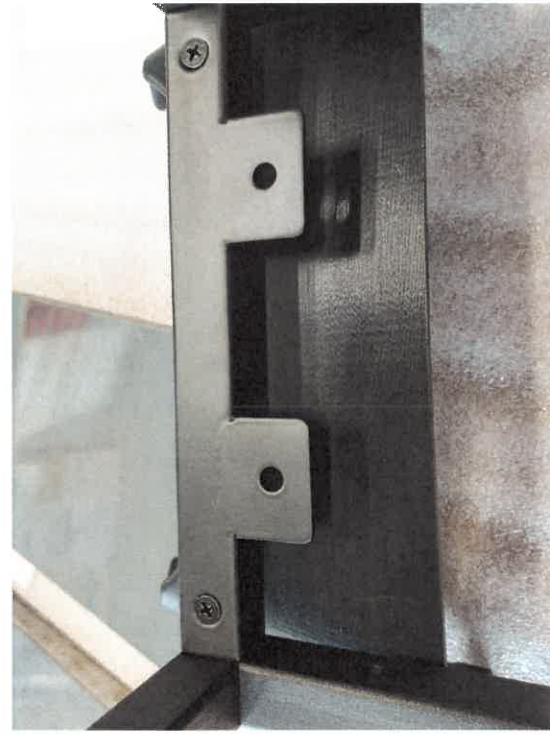
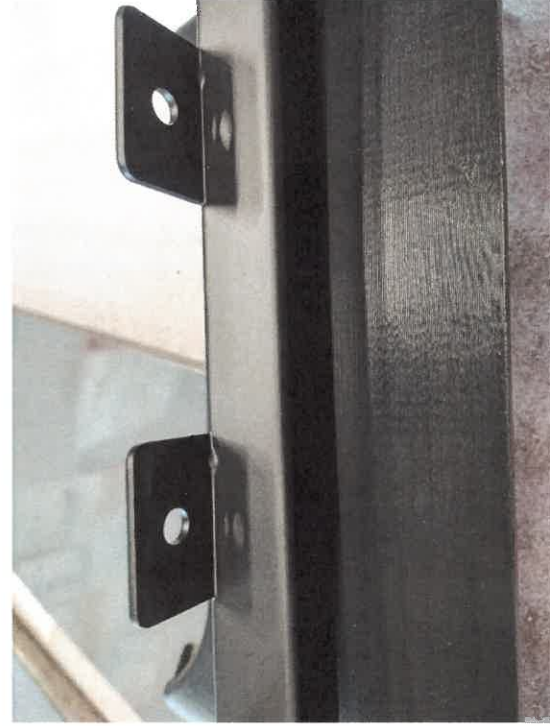
**L36 coating**

| Sample no | Product | Quantity | Description after 96 hour test |
|---|---|---|---|
| 2 | Frame in L36 coating | 1 pc | The element has been visually assessed after:<br>- 96 h - no visible changes on external surfaces; traces, leakage of internal corrosion visible at welds, mounting holes and in places of connection |

| No. | Sample no | Description | Test result |
|---|---|---|---|
| 2. | Frame in L36 | Slight rusting at holes, welds, in places of connection between 0,25 and 0,5 %, 7/7 s | For customer approval |
